### Complaint Against the Valuation of Real Property

3206 Hustead Road, Springfield, OH 45502

# Home Inspection Report

These are supporting documents  
for the valuation appeal by Kathy Herriot  
for the real estate at 3206 Hustead Rd  
Springfield, Ohio 45502

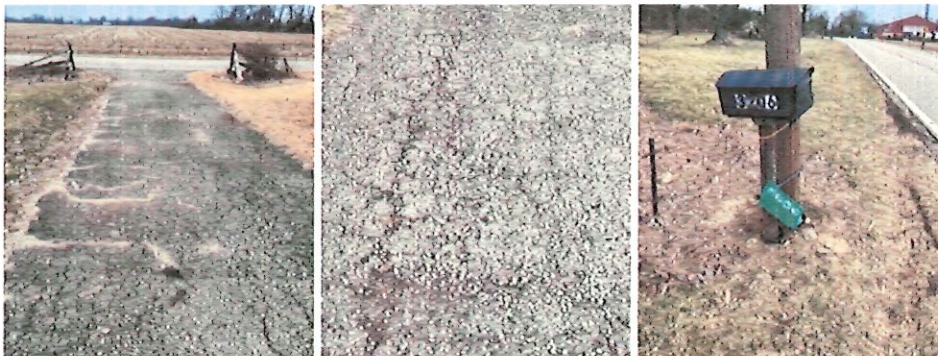
The mailbox post broke off at the ground recently and should be replaced asap.

Typical cracking for asphalt this age.

Recommend sealing crack(s) and resurfacing as needed

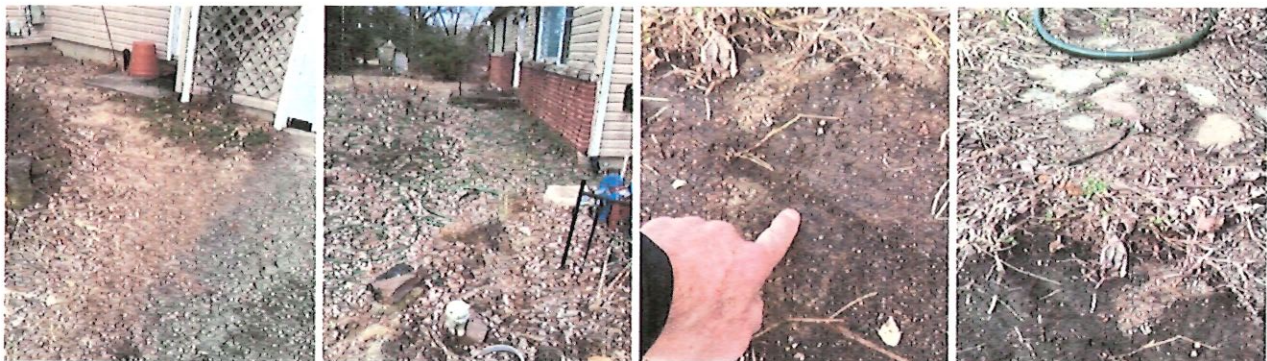
There are some pavers visible and more found under grass, dirt and debris. I recommend a heavy raking of the walk areas to bring walkway back to life and rid future trip hazards.

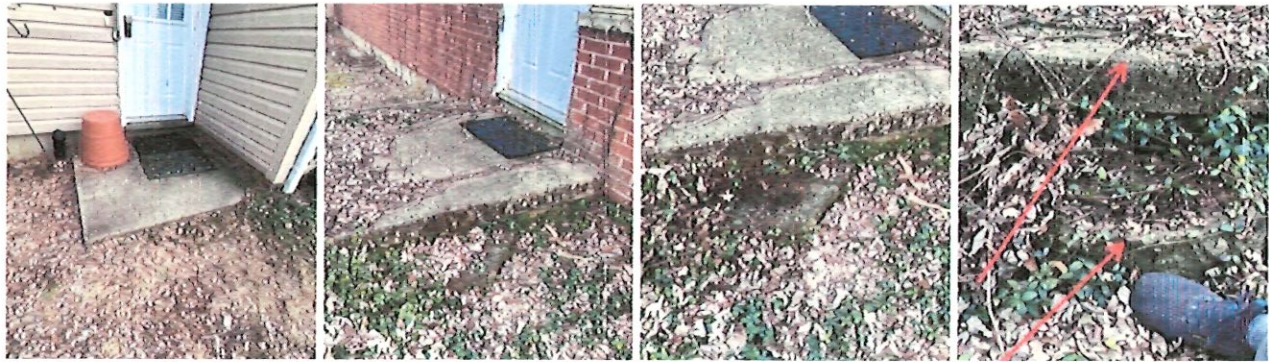
hazard. I recommend adding aggregate under the rock step to make the risers equal.

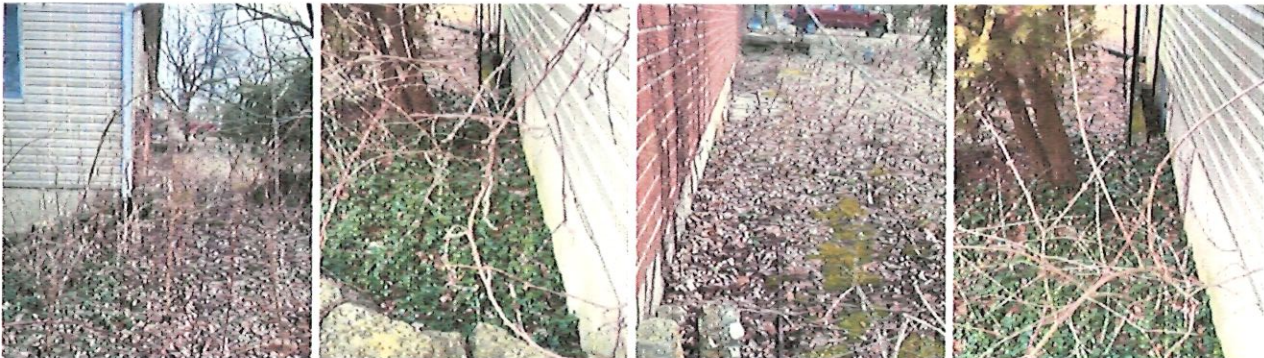
Improper slope is draining water towards the foundation which contributes to moisture and water penetration in the basement

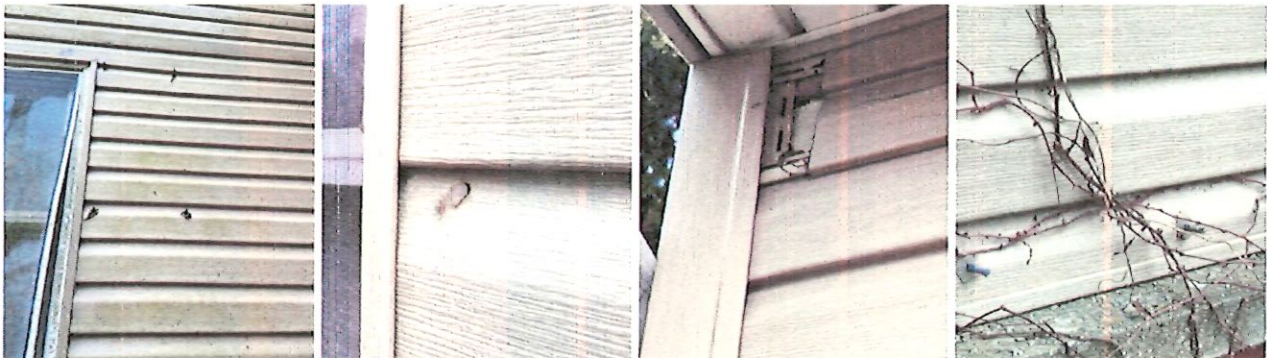
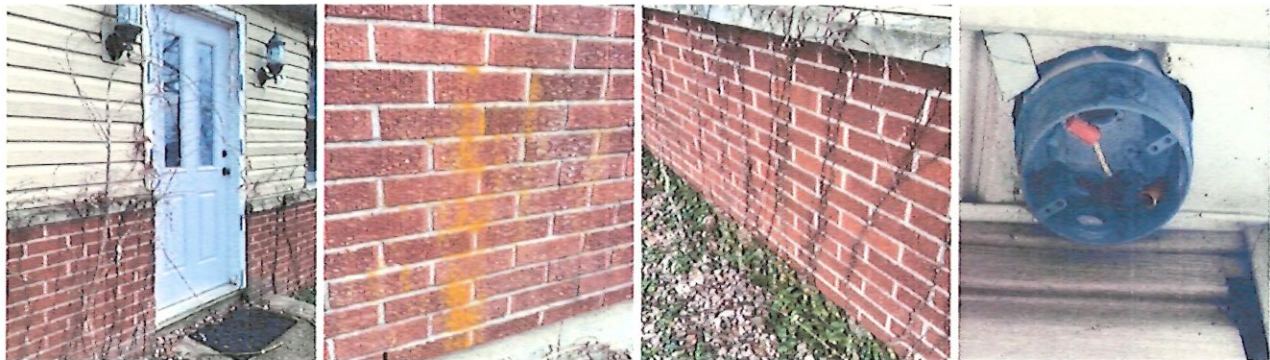
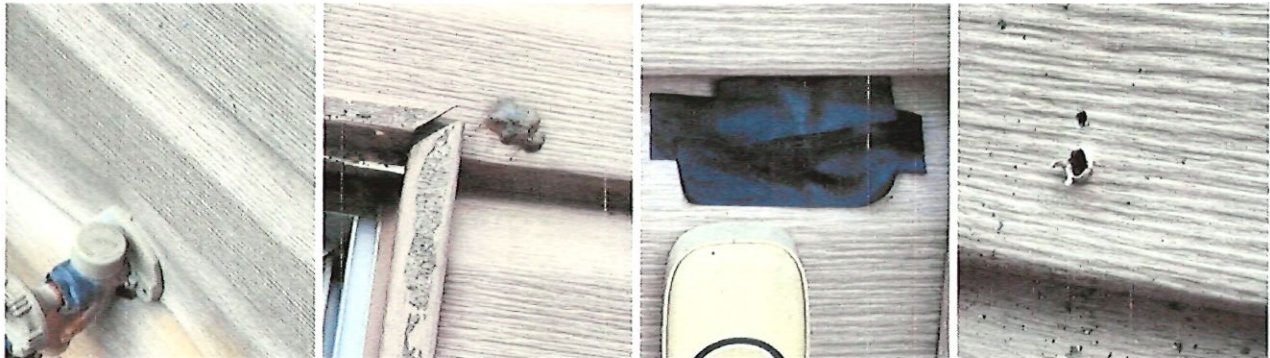
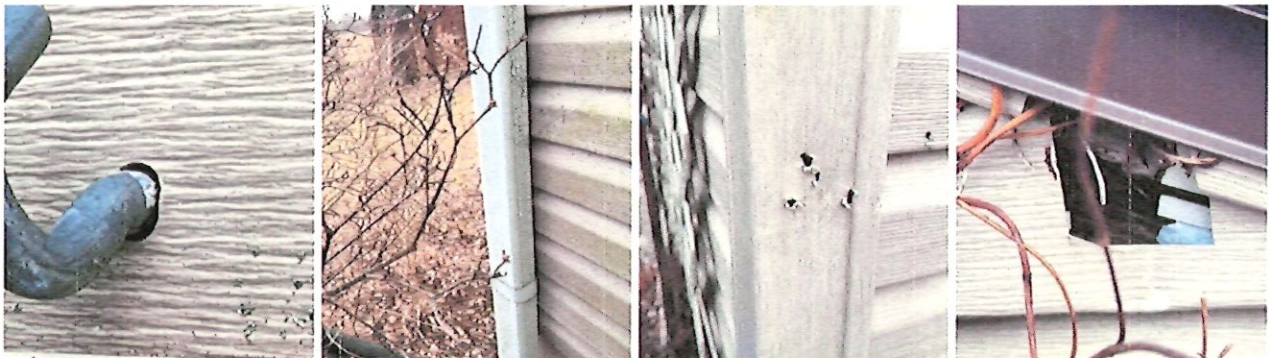
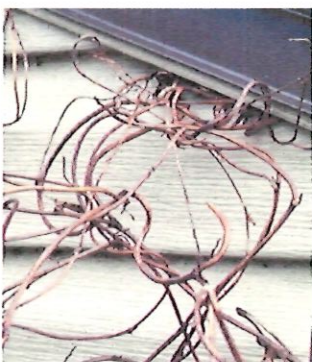
Any and all holes, gaps, and cracks in the siding should be sealed with a high quality sealant and the missing siding should be replaced with siding.

Vegetation should not be allowed to grow on the brick or siding. It can damage them and lead to moisture and pest infiltration. Recommend removal

Vegetation is growing on the brick/siding, which can cause damage and lead to moisture intrusion and pest issues. Recommend removing vegetation to prevent potential structural and pest-related problems. Regular maintenance is advised to ensure clearance.

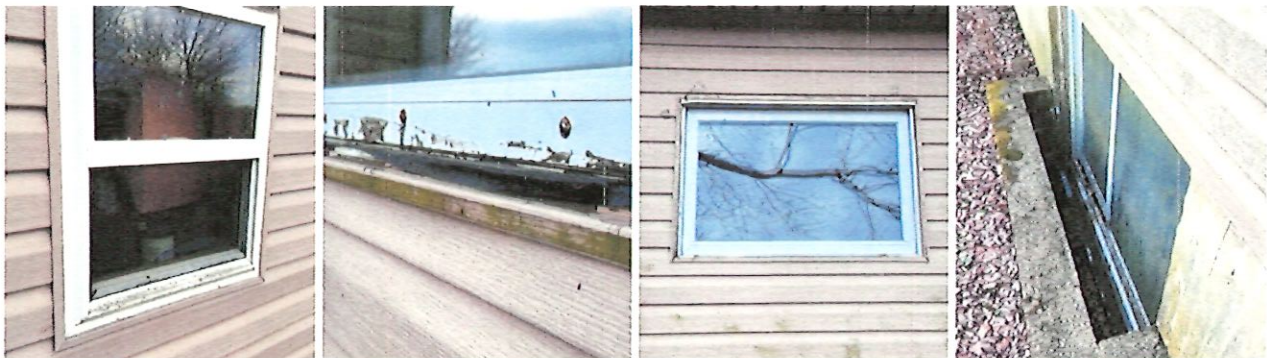
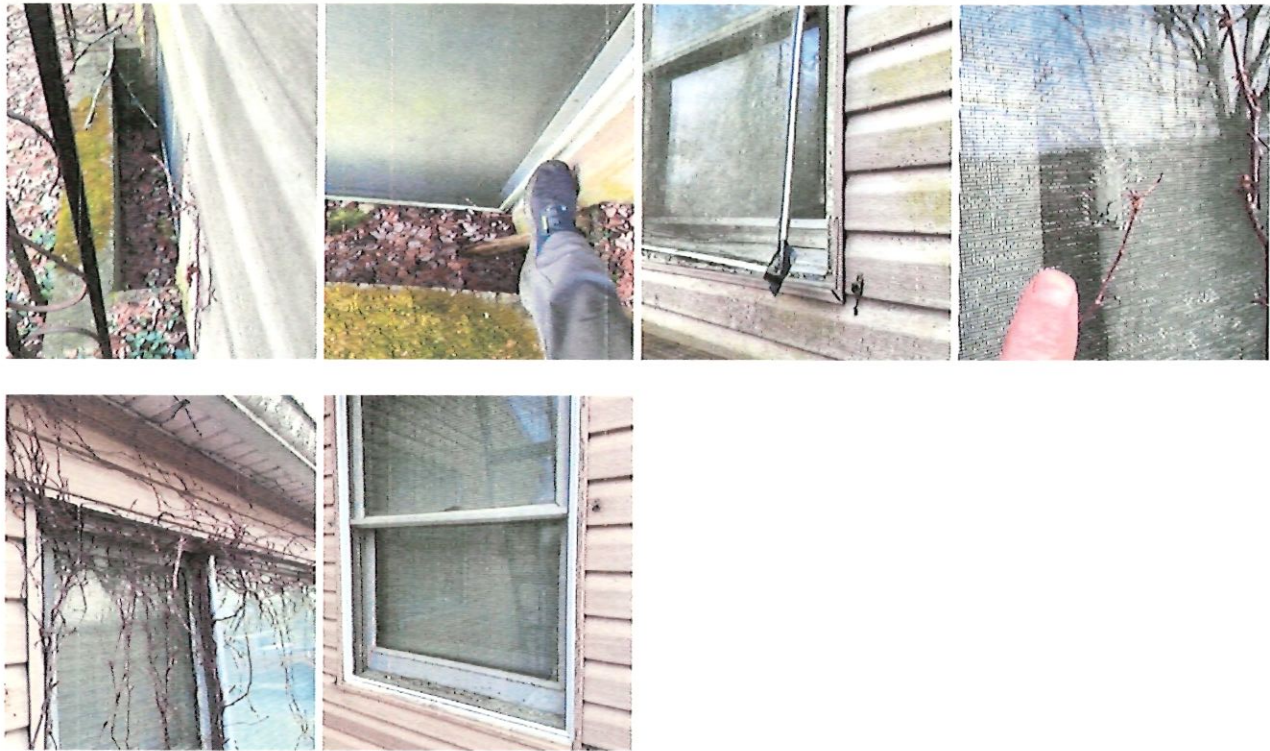
Many of the windows were not inspected for operation due to the plastic covering on the interior side. I recommend a thorough cleaning of the windows, tracks, and frames inside and out to determine which windows may need to be replaced.

Screens torn/damaged or missing.

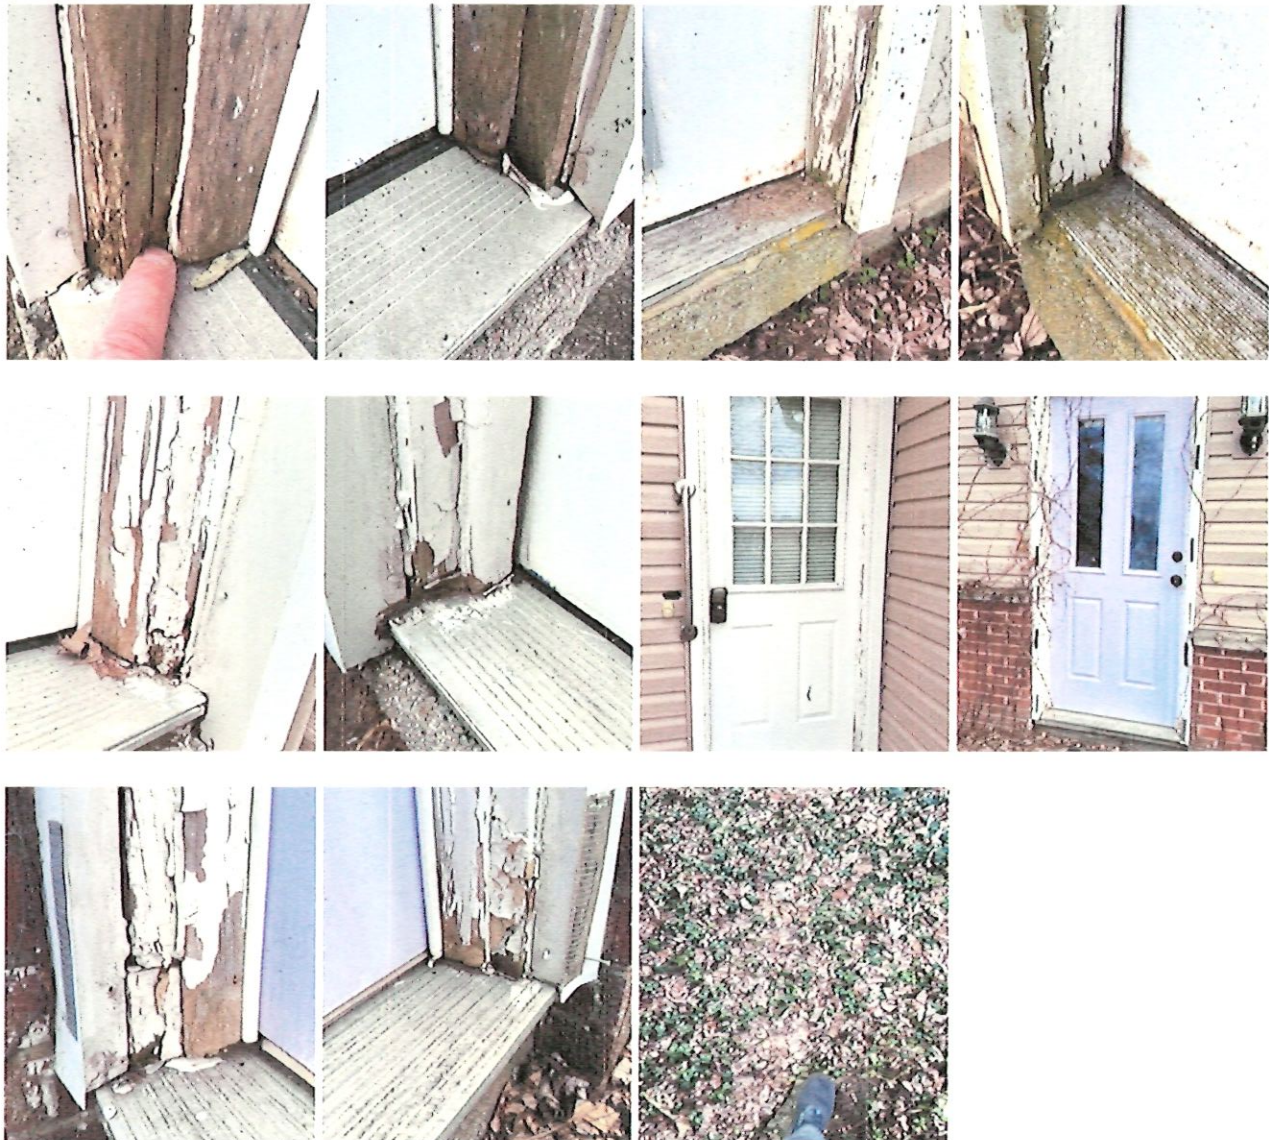
Paint peeling

The exterior door frames near the bottom have begun to rot and decay from water intrusion. There are waterstains in the basement on the subfloor where water has penetrated the structure near the door. I recommend replacing the doors and frames as the doors are showing rust also. Contractor should survey the damage beyond the doorframe and fix/replace before reinstalling new door. Before it gets worse.

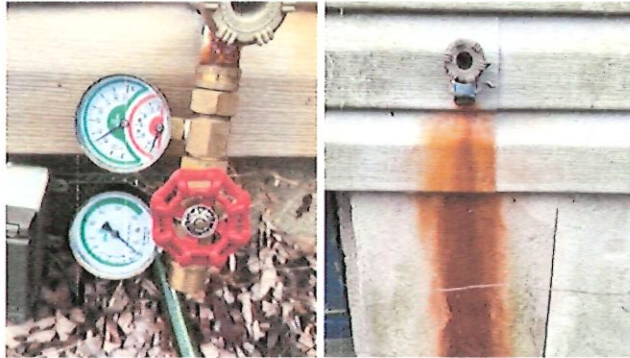
The water stains on the siding below the hose bib are signs of past or present leakage.

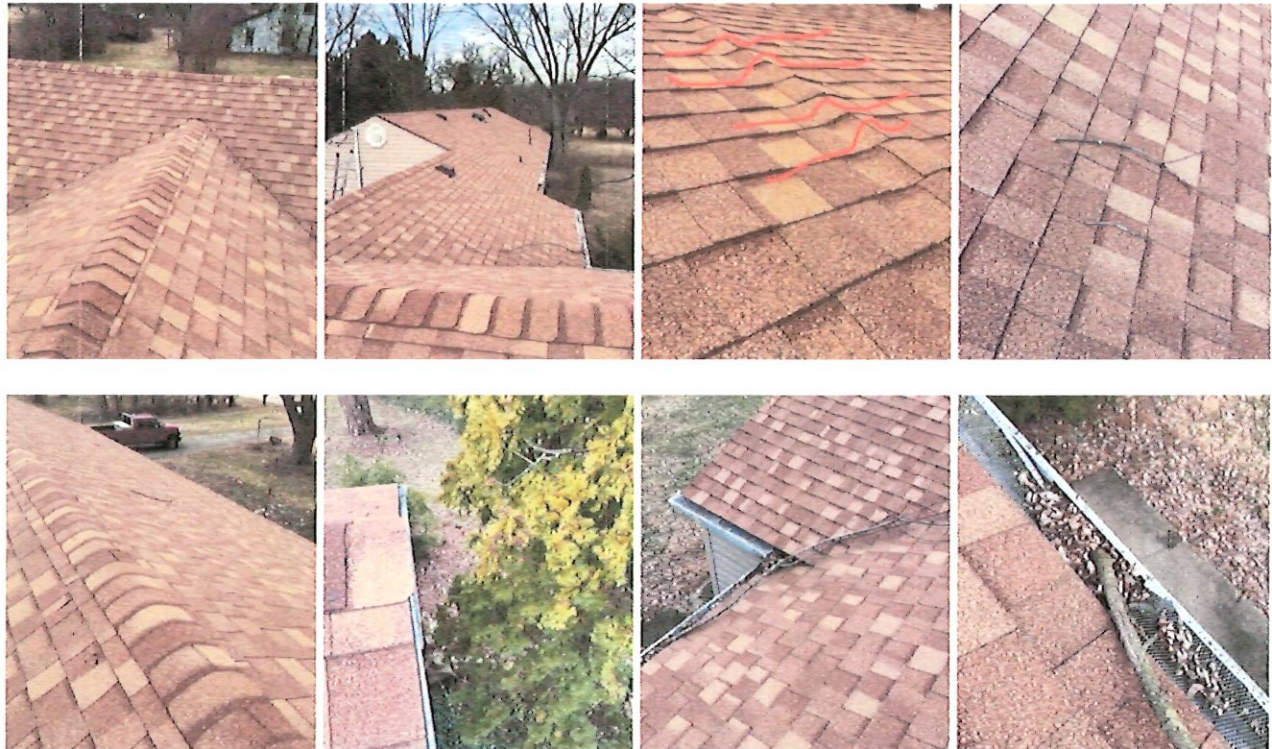
The shingles have an obvious bug between the house and the "breezeway". No signs of the roof leaking there today. I recommend this area from the gutter to the peak to be replaced.

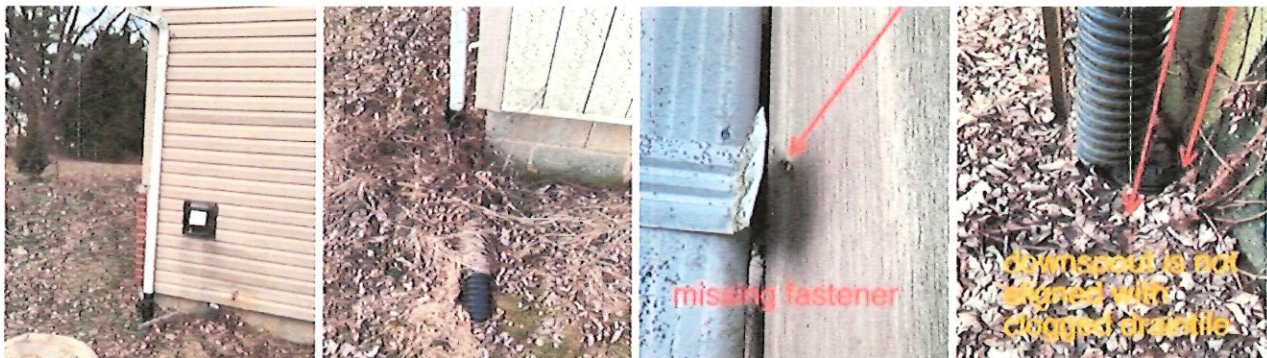
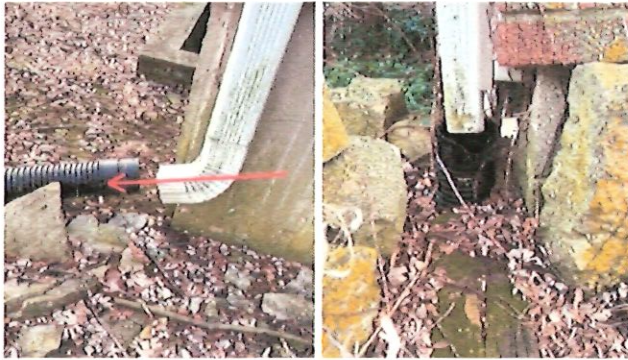
Loose or missing clamp(s)

Leader(s) do not extend 6 ft. beyond the foundation perimeter

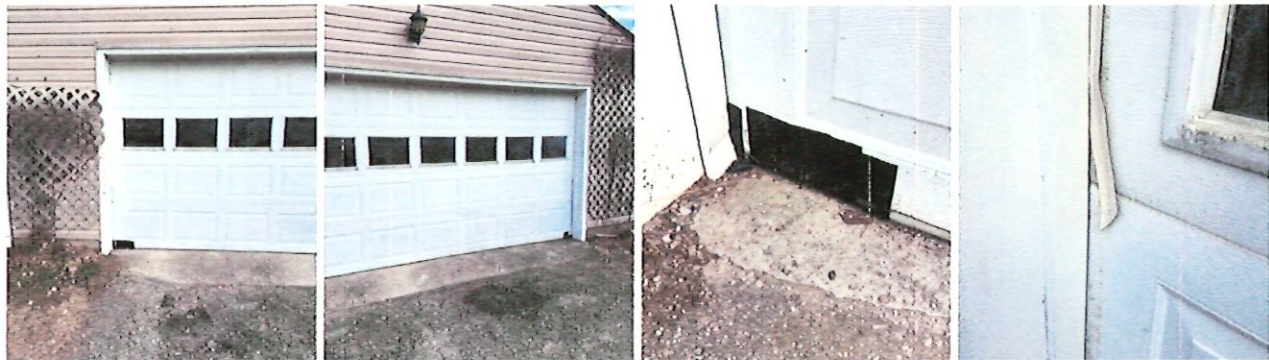
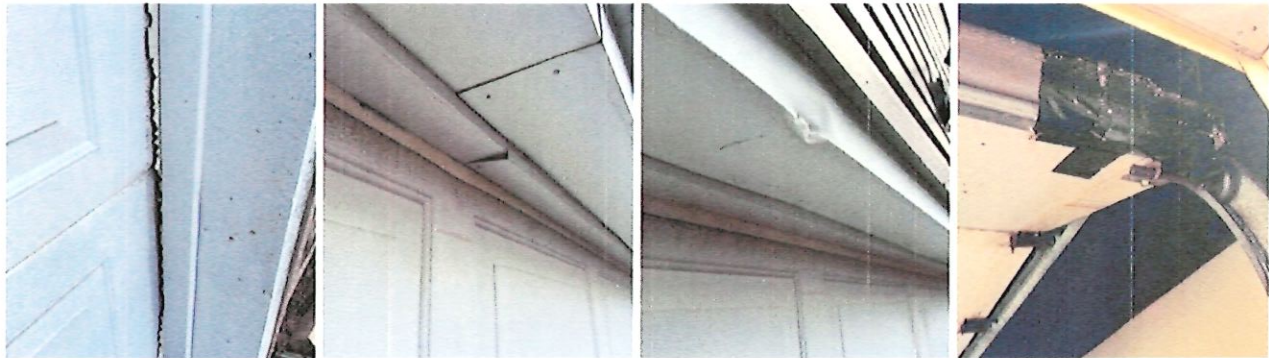
Weatherstrip bad

Loose nail

Fascia damage garage

The garage door hinges have been moved on the garage door. It appears over time the screws fatigued the door metal and wouldnt hold well. There are screws missing in the door stiffener bar and it sags plenty when opened. I recommend replacement of the door.

Weather seal(s) loose or damaged

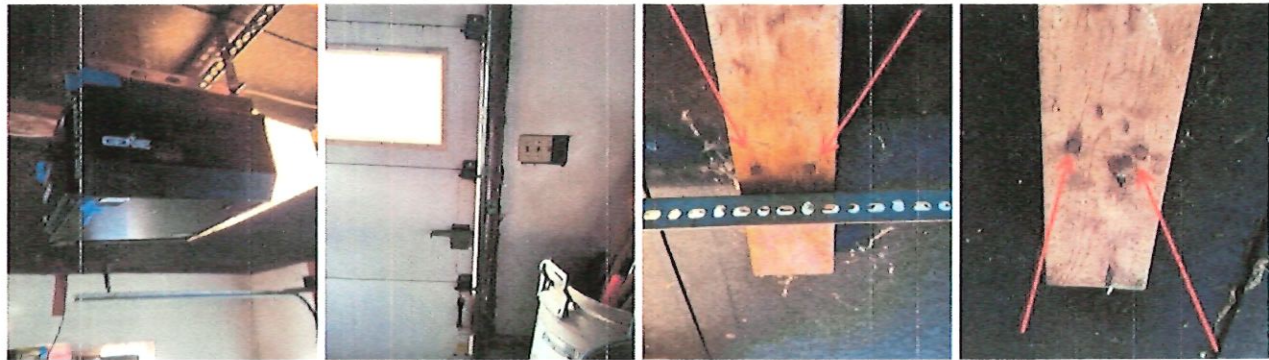
The 2x4 lumber holding the garage door opener and chain rail are attached to the ceiling with nails. It may hang there forever but I recommend replacing the nails with heavy duty structural screws or lags.

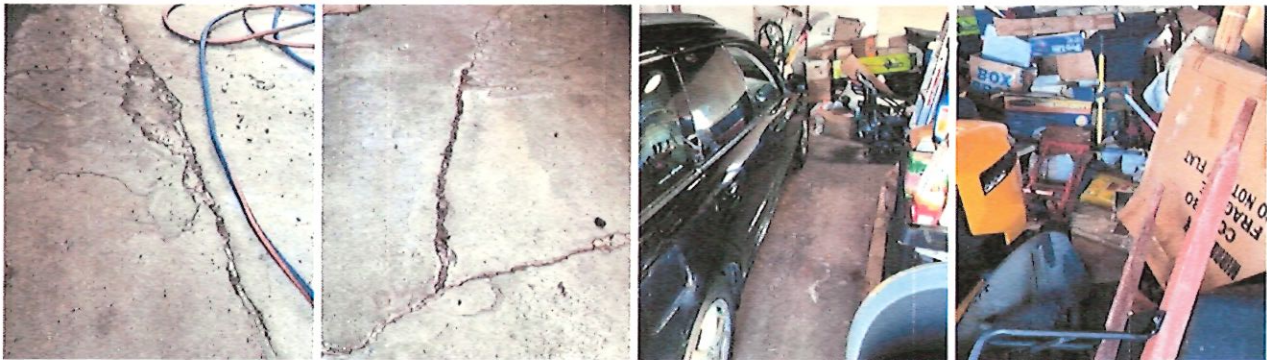
Minor floor crack(s)

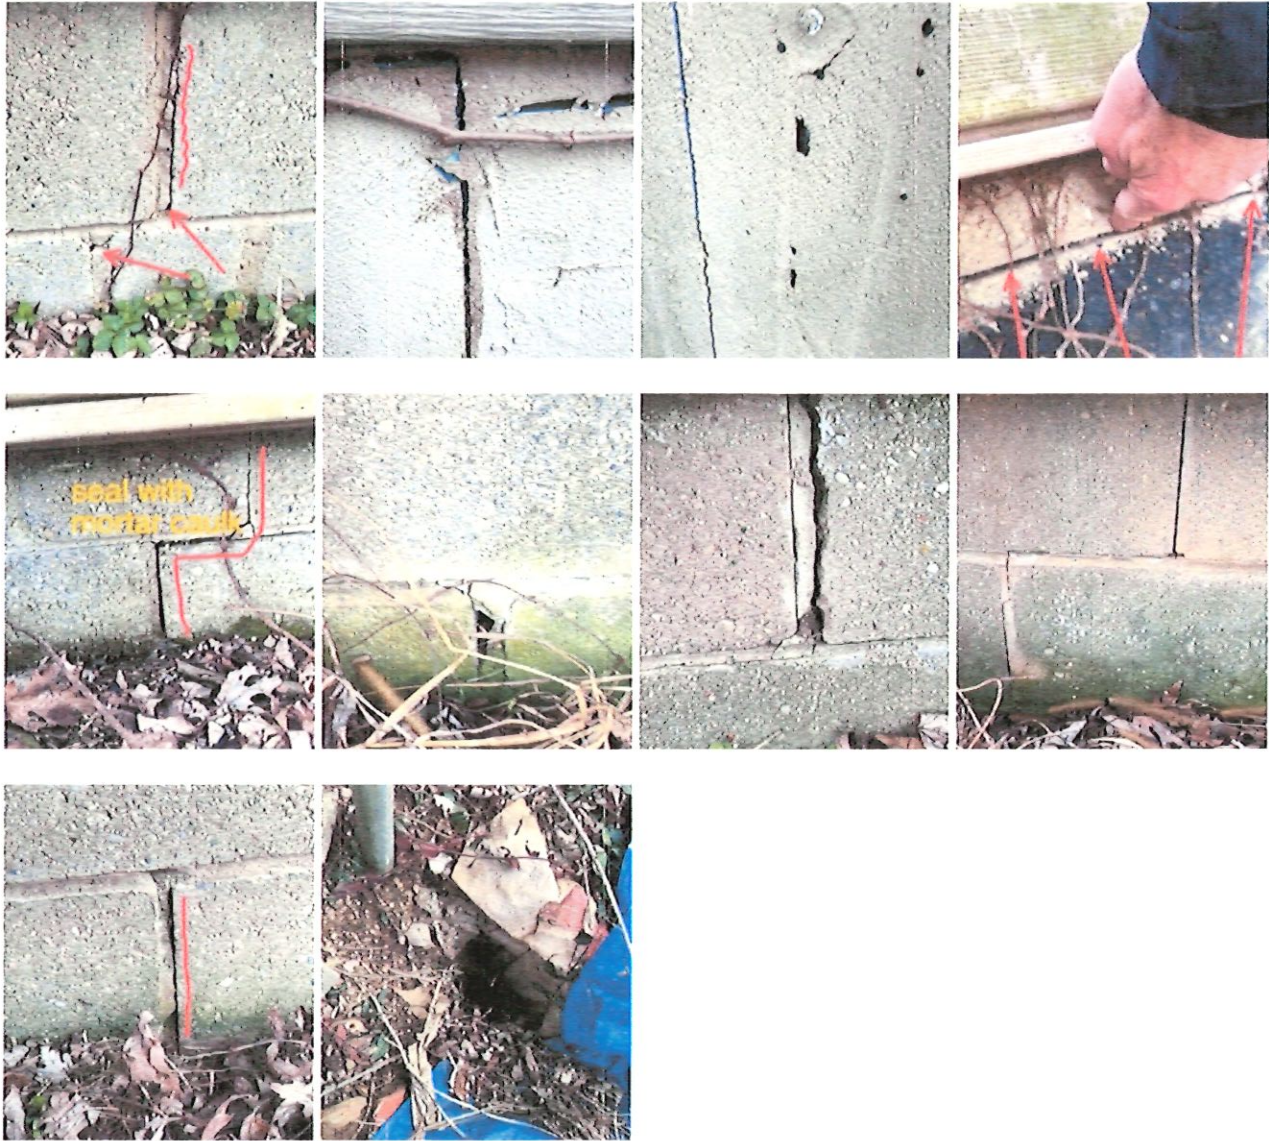
The small cracks between the foundation block and mortar should be resealed. Non shrinking mortar caulk works well and comes in a few colors to help match.

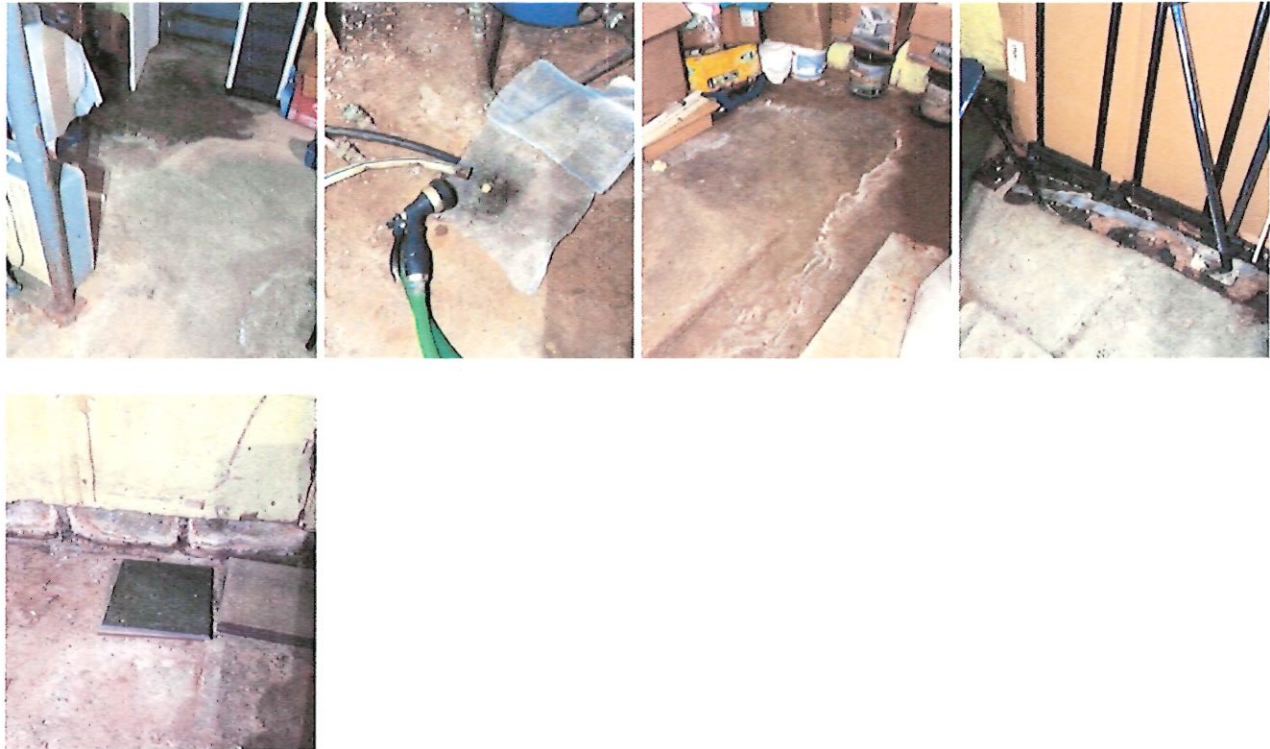
There is evidence of water being on the basement floor in the past. The floor was dry today. I recommend having a battery backup sump pump installed for when the primary goes out and a second primary in stock to replace it quickly in case of failure since the basement is known to flood.

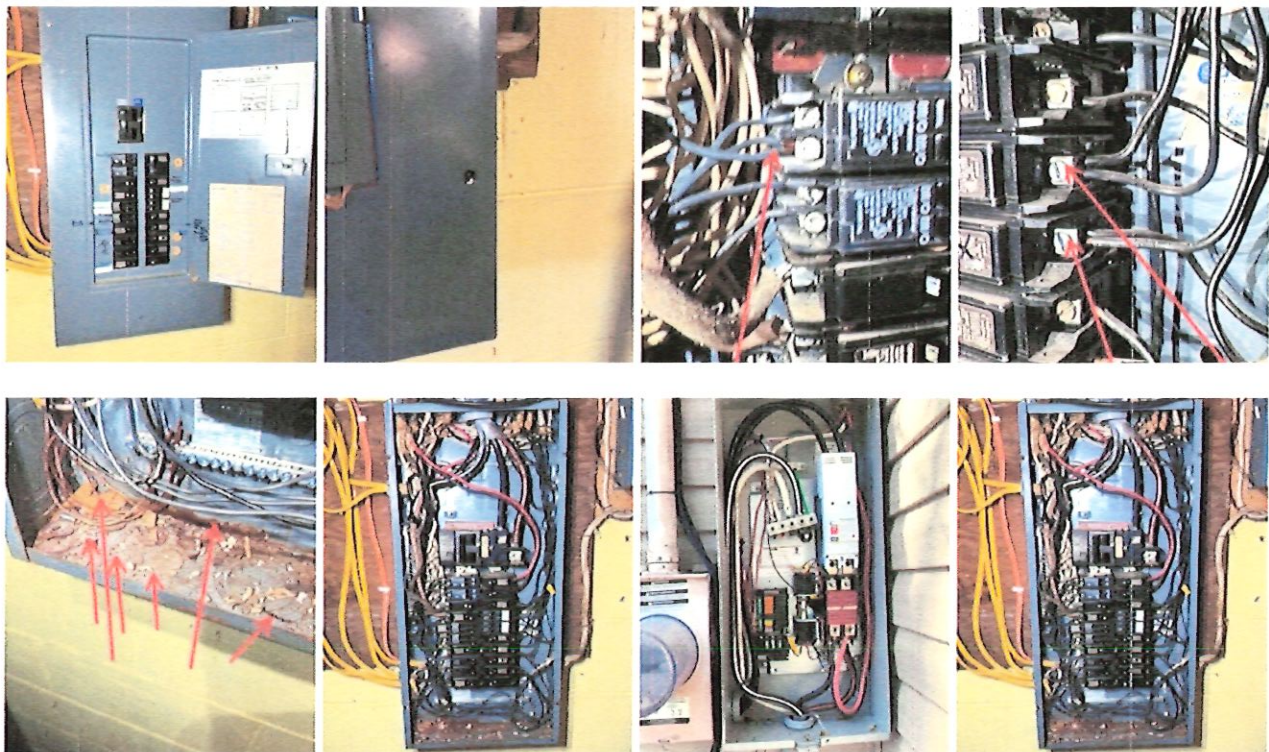
No rust or debris should be inside the electric main panel. Further evaluation by a qualified electrician is recommended.

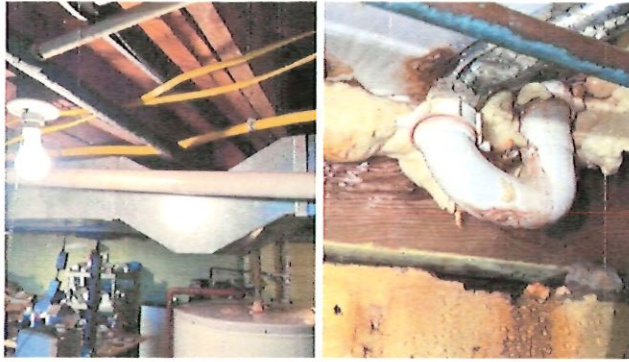
Leaking observed under the bathtub drain in the basement.

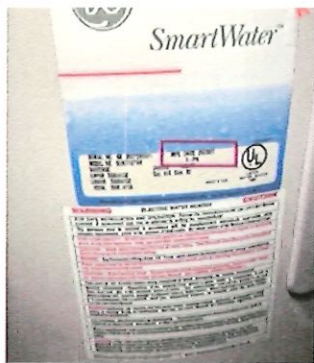
The dry bucket under the tpr discharge on the water heater should not be there. The tpr must always discharge 6-8" from the floor into the open air. if it were to leak and fill the bucket it would not be in open air and creates an unsafe situation.

Water heater has exceeded its design life of 8-12 years as it is nearly 19 years old. Budget for replacement soon.

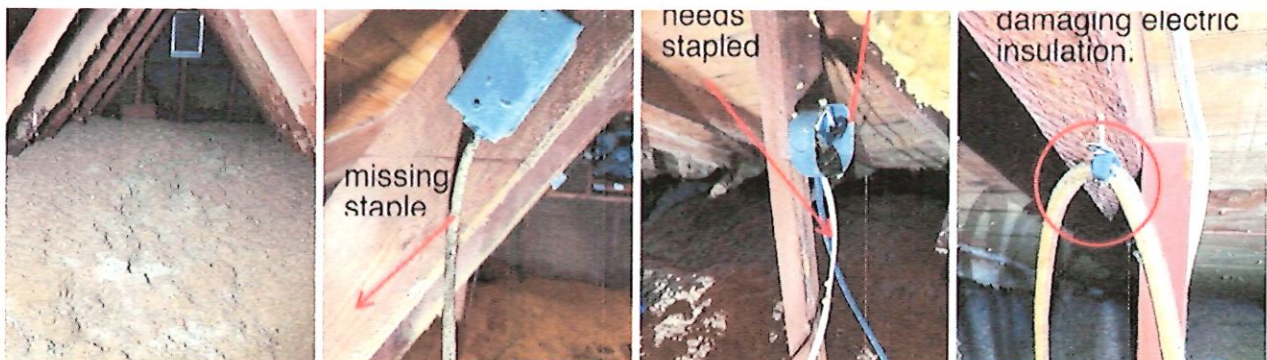
missing box cover and missing electric staples in the attic.

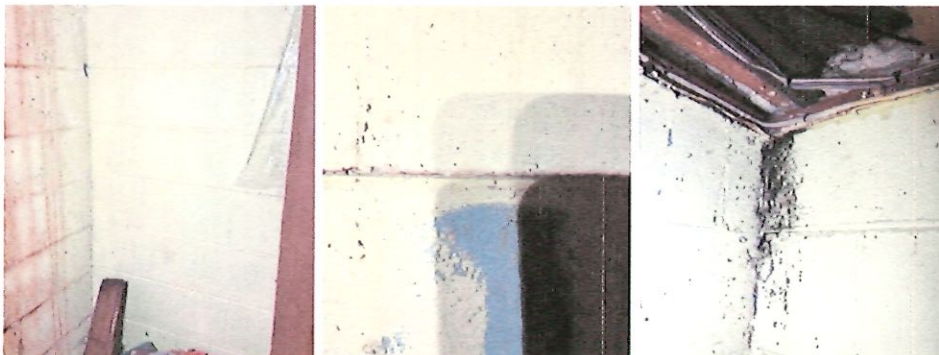
Typical cracking/flaws were observed in wall finish

Possible mold observed. Recommend that a qualified contractor evaluate and estimate repairs.

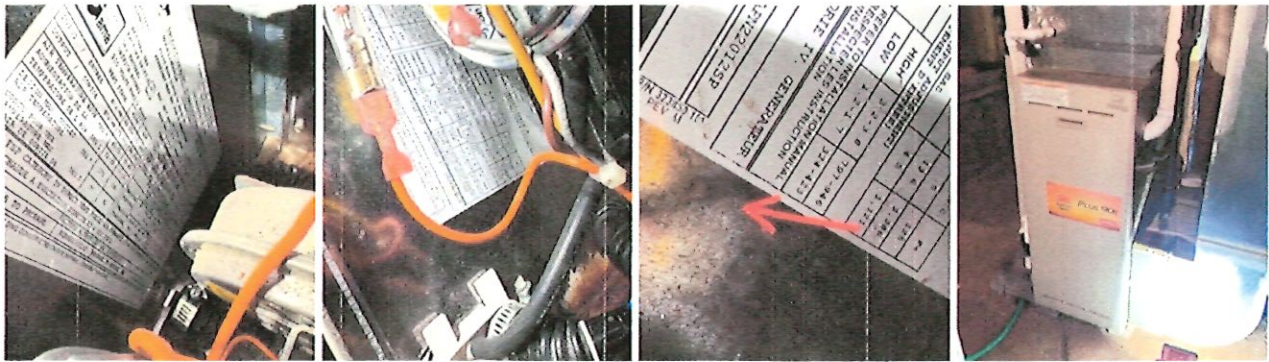
The furnace is nearing 23 years old and the average life expectancy is 15-20 years. budget for replacement soon.

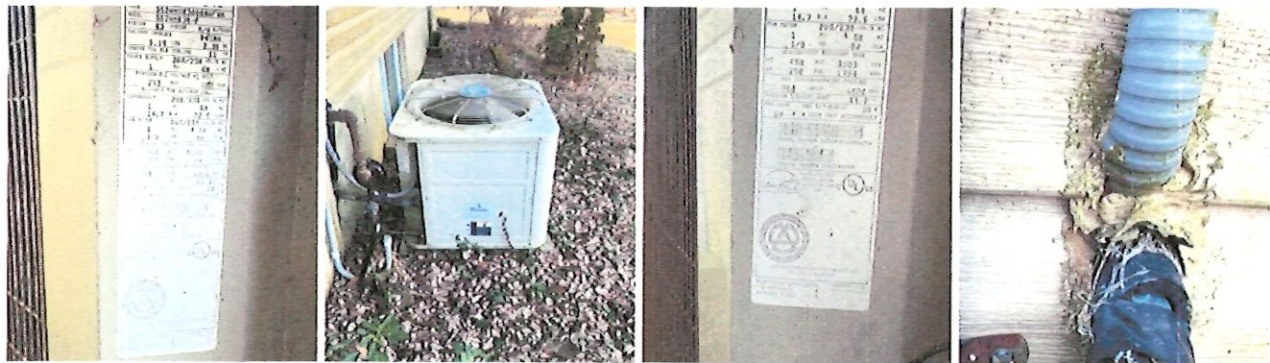
The AC i it was built in 2003 and has outlived its average service life of 12-15 years.

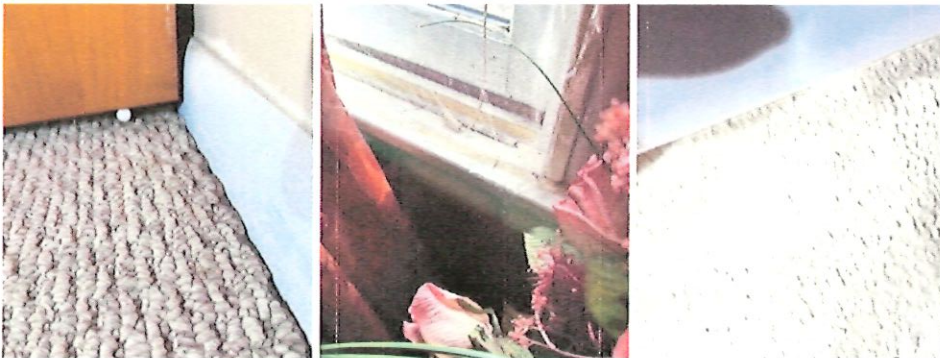
Lead paint

Note this house was constructed prior to 1979. It needs to be understood that various interior components were painted with lead based paint at time of construction. Additionally exterior wood components were painted with lead based paint. Lead based paint dust or paint chips when inhaled or ingested has been documented to cause brain and nervous system issues in humans, particularly young children. These issues to brain and nervous system function are not reversible. The EPA has established the RRP law which defines protocols for contractors

to follow during renovating and/or removing lead paint components. These protocols create safe house conditions for both the occupants and workers. Contractors must be RRP certified through EPA training to perform lead based paint remediation. Highly recommend prior to the start of any home renovations to have all painted wood components tested for lead based paint by a certified lead paint assessor.

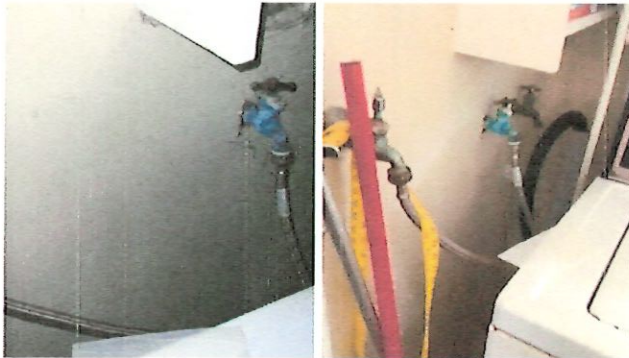
The hose(s)/valve(s) were inspected visually and was not tested. The washing machines water supply lines are fed from two different locations indicating a plumbing defect. I recommend a qualified plumber to remedy this.
