### Complaint Against the Valuation of Real Property

3206 Hustead Road, Springfield, OH 45502

# Home Inspection Report

These are supporting documents  
for the valuation appeal by Kathy Herriot  
for the real estate at 3206 Hustead Rd  
Springfield, Ohio 45502

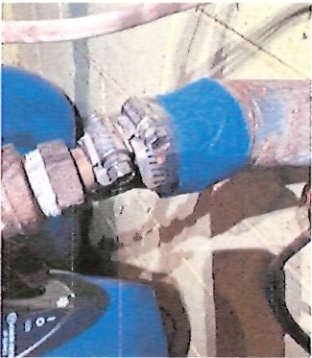
/Galvanized service line(s) present in the basement. I Recommend replacement before you notice any issues.
